## Event Controller Upgrade Issue Recovery Guide

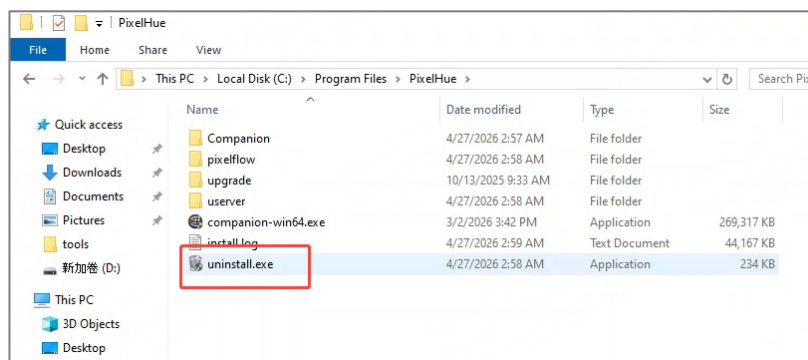
#### 1. Uninstall: 1 to 2 minutes

- Cause of the issue: The software auto-start configuration was not written to the system startup.
- Recovery method: Uninstall and reinstall the software.

Run as administrator: C:\Program Files\PixelHue\uninstall.exe.
